LEARNING MATTERS

Welcome to
Learning Matters
Special Edition 15
January 2021

Reducing the risk of oxygen tubing being connected to air flowmeters

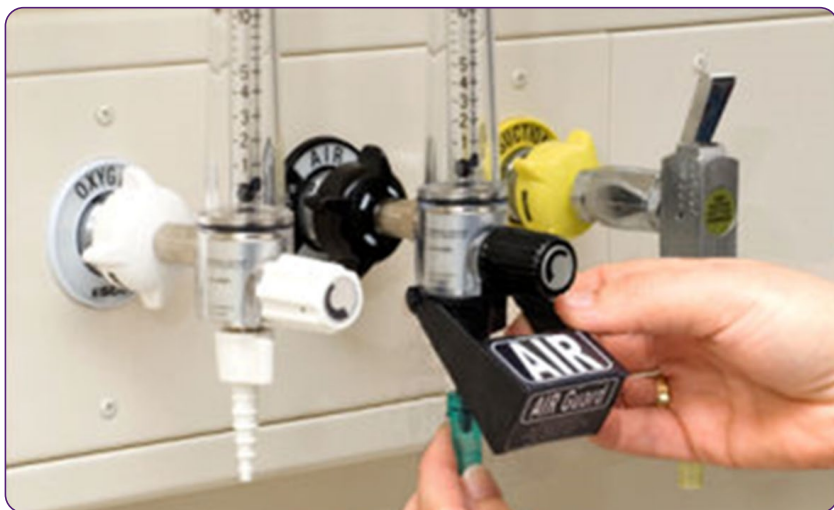
Figure 1
AIR FLOWMETER WITH MOVEABLE FLAP

In one of the reported SAIs/Never Events, the moveable flowmeter flap fitted to air flowmeters, which aims to provide an additional visual cue was in place, however it **did not** prevent the error occurring and the patient was inadvertently connected to air instead of oxygen. It is therefore important to recognise that the visual moveable flap is an error-reducing solution **rather than** an error-proofing solution (see figure 1).

- 3. Air flowmeters are fitted with a labelled, movable flap.** (Figure 1)

The lettering on the flap is larger and more visible than on the flowmeter itself and this flap has to be lifted to attach a tube. This acts as a further barrier to unintended connection if staff occasionally forget to remove medical air flowmeters after a period of active use. This will provide visual and tactile prompts but may not be sufficient to prevent all errors.

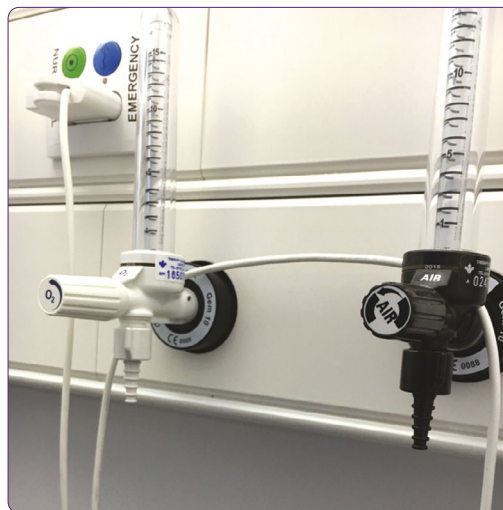
Figure 2
OXYGEN AND AIR FLOWMETERS

As below in Figure 2, medical air outlets and oxygen outlets are located beside each other but the outlet connections are different. Air flowmeters are coloured black and oxygen flowmeters are coloured white in the UK and Europe to differentiate them (HSIB, 2019)

As seen in figures 2, 3 and 4, air and oxygen flowmeters have identical universal fir tree connectors, meaning medical gas tubing can fit on either, which is an additional equipment design issue that makes it easy for error to occur.

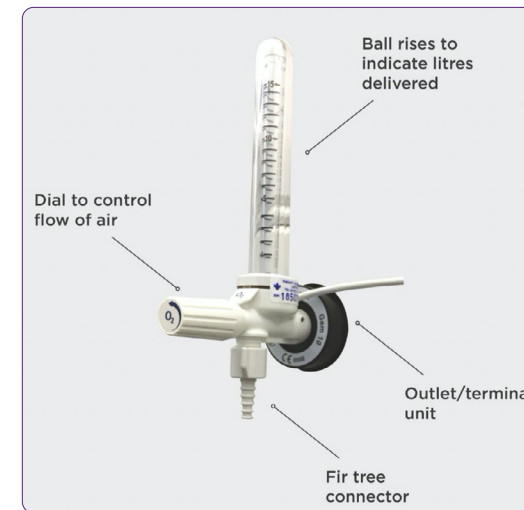
Figure 3
COMPONENTS OF A FLOWMETER

Figure 3 provides detail of the various components of a flowmeter

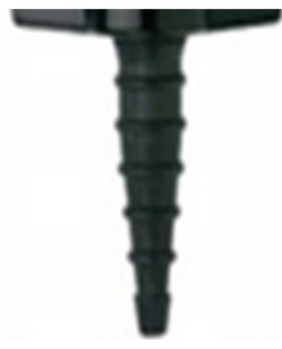
Figure 4

FIR TREE CONNECTORS – OXYGEN AND AIR

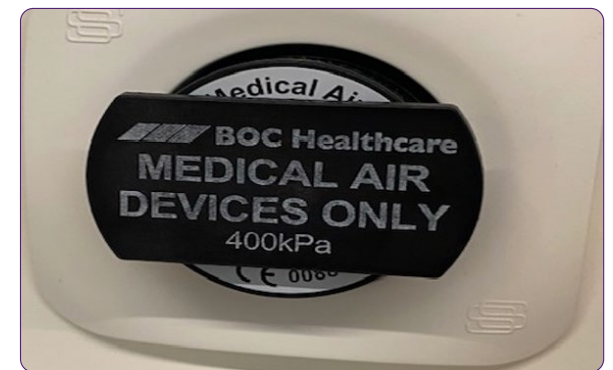
Figure 5

- 1. Medical air terminal units (wall outlets) are covered with designated caps in areas where there is no need for medical air.** (Figure 5)

DESIGNATED MEDICAL AIR DEVICES ONLY CAP

Medical air outlets were traditionally built into most clinical areas for the delivery of nebulised treatment but not all areas need them (e.g. they never have patients who need nebulisers, or they have access to electrically driven compressors or ultrasonic nebulisers).
